# Southwest Minnesota State University

## MASTER FACILITY PLAN 2017

100% | 2.13.2018

- Overall Summary by Campus dated August 4, 2015
- All Buildings dated August 4, 2015
- Backlog & 10 YR Renewal by Subsystem dated August 4, 2015
- Full Facility Roof Report dated January 26, 2016 prepared by Roof Spec, Inc.
- Recommendations - All dated January 26, 2016 prepared by Roof Spec, Inc.
- Financial Plan - Total (5 Years) dated January 26, 2016 prepared by Roof Spec, Inc.
- Roof Plans Prepared by Roof Spec, Inc.

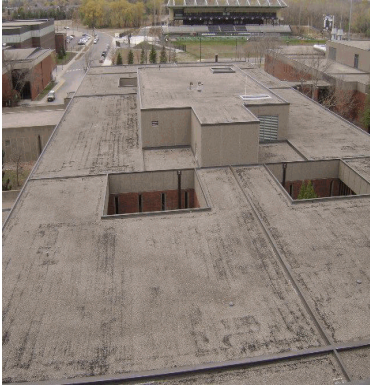
A1, A2 E26075S0167 1989	54,200 sq. ft.	MnSCU Std. 4-Ply Asphalt	1 (Yrs)	\$1,029,800.00

Section ID	Budget Year	Activity Type	Budget Amount
A1, A2	2016	Repair	\$5,000
<p>Perform remedial maintenance as necessary until reroofing is accomplished.</p> <p>If reroofing is scheduled beyond 2017 recommend performing the following:</p> <p>Resurface ridges in membrane, remove all vegetation from the roof and trim overhanging trees, install new sealant where missing or deteriorated and replace suspected wet insulation.</p>			
A1, A2	2017	Replacement	\$1,248,000
<p>Section A1 replacement. Emergency repairs should be performed as needed to maintain a watertight condition until replacement takes place.</p>			
A1, A2	2017	Replacement	\$1,512,000
<p>Section A2 replacement. Emergency repairs should be performed as needed to maintain a watertight condition until replacement takes place.</p>			
B	2016	Replacement	\$800,000
<p>Emergency repairs should be performed as needed to maintain a watertight condition until replacement takes place.</p>

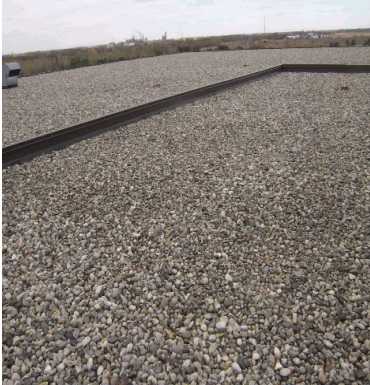
B E26075S0167 1989	17,500 sq. ft.	(EPDM-B) Ballasted Ethylene-Propylene-Diene-Monomer	0 (Yrs)	\$350,000.00

Budget Year	Activity Type	Quotation \$
2016	Replacement	\$800,000
Emergency repairs should be performed as needed to maintain a watertight condition until replacement takes place.		
		<b>\$800,000</b>

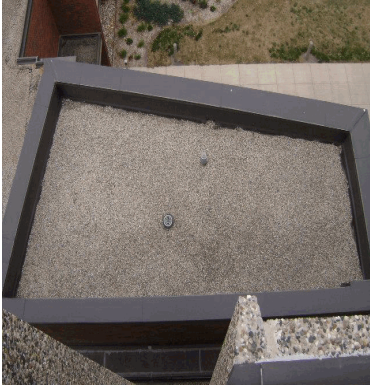
C E26075S0167 2004	551 sq. ft.	4-Ply Built-up Asphalt Roofing	18 (Yrs)	\$19,836.00
<b>72,251</b>					<b>\$1,399,636.00</b>

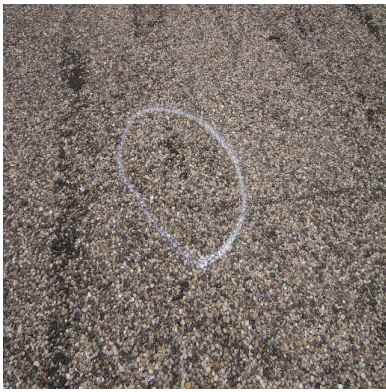
ID#: 1      OBSERVED: 10/10/12

Defect Type	Severity	Quantity	Unit
Defect #01	Monitor	3	sq. ft.

Blister that is watertight - no apparent damage

REPAIR: Monitor for repair need prior to reroofing

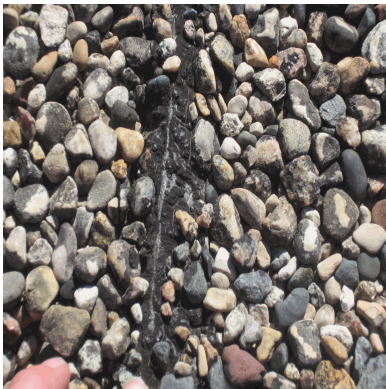
ID#: 2      OBSERVED: 10/10/12, 9/23/2015

Defect Type	Severity	Quantity	Unit
Defect #02	Monitor	10	linear ft.

REPAIR: Install additional aggregate surfacing in hot asphalt over the ridge formation.

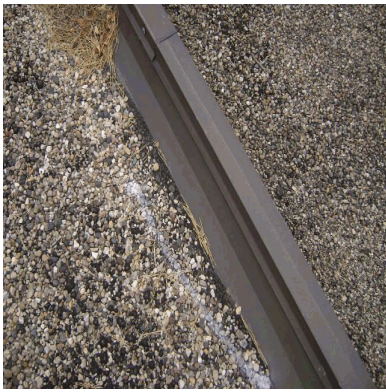
ID#: 3 OBSERVED: 10/10/12, 9/23/2015

Defect Type	Severity	Quantity	Unit
Defect #03	Monitor	200	sq. ft.

REPAIR: Monitor for repair need prior to reroofing

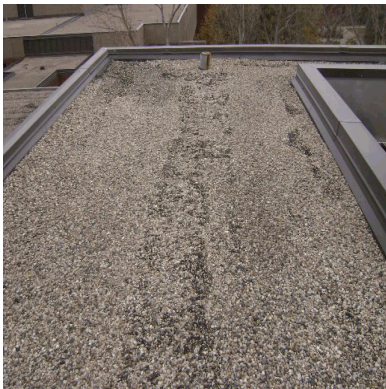
ID#: 4 OBSERVED: 10/10/12, 9/23/2015

Defect Type	Severity	Quantity	Unit
Defect #04	Monitor	50	sq. ft.

Surfacing loss with no membrane deterioration/damage

REPAIR: Monitor for repair need prior to reroofing

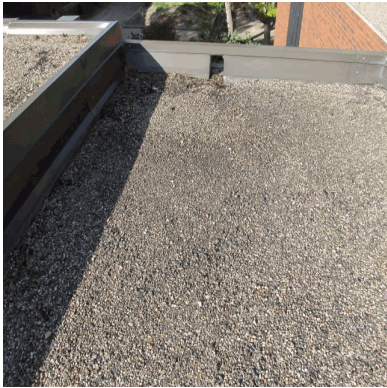
ID#: 5 OBSERVED: 10/09/13, 9/23/2015

Defect Type	Severity	Quantity	Unit
Defect #05	Monitor	30	sq. ft.

Ponding exists

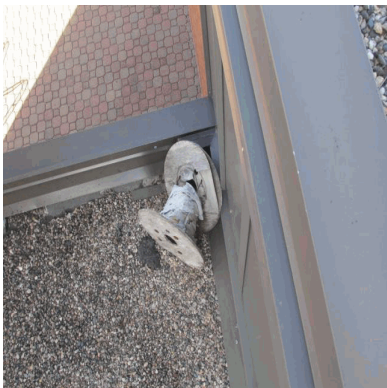
ID#: 6 OBSERVED: 10/09/13, 9/23/2015

Defect Type	Severity	Quantity	Unit
Defect #06	Repair	1	Ea.

REPAIR: Remove debris/vegetation/foreign materials. Trim trees overhanging roof.

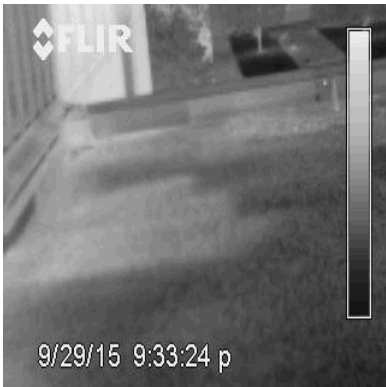
ID #7 OBSERVED: 9/23/2015

Defect Type	Severity	Quantity	Unit
Defect #07	None	20	sq. ft.

Suspected wet insulation

Approximately 20 square feet of suspected wet insulation observed.

REPAIR: Verify wet insulation with a core of the existing roof. Remove and replace wet materials.

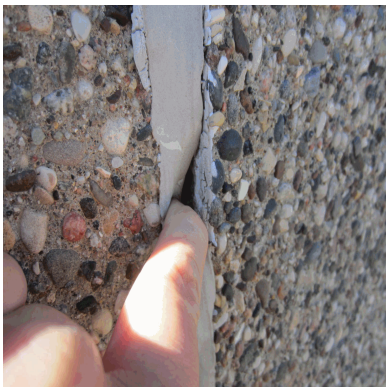
ID #8 OBSERVED: 9/23/2015

Defect Type	Severity	Quantity	Unit
Defect #08	Repair	100	linear ft.

Missing/Deteriorated sealant

REPAIR: Install new sealant.

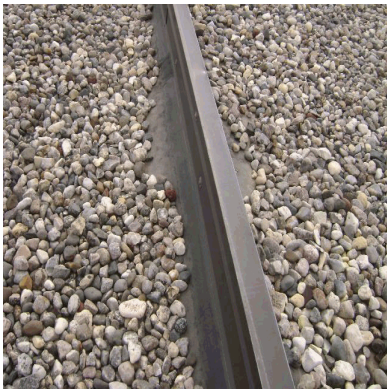
ID#: 1    OBSERVED: 10/10/12; 10/09/13, 9/23/2015

Defect Type	Severity	Quantity	Unit
Defect #01	Monitor	90	Ea.

REPAIR: Monitor for repair need prior to reroofing

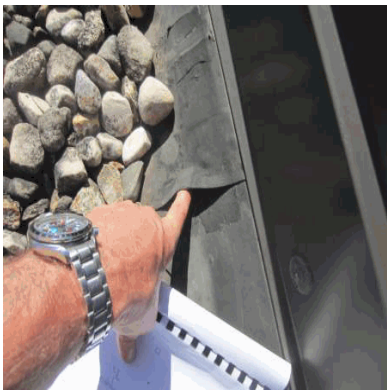
ID #2    OBSERVED: 9/23/2015

Defect Type	Severity	Quantity	Unit
Defect #02	Repair	1	Ea.

REPAIR: Install EPDM over open flashing seam.

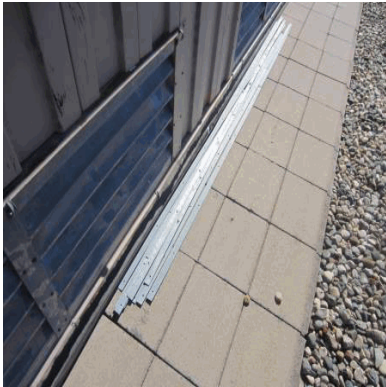
ID #3 OBSERVED: 9/23/2015

Defect Type	Severity	Quantity	Unit
Defect #03	Repair	1	Ea.

REPAIR: Remove debris from roof.

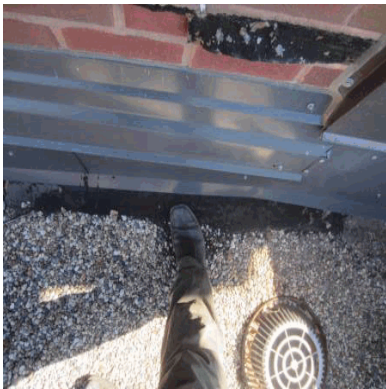
ID #1 OBSERVED: 9/23/2015

Defect Type	Severity	Quantity	Unit
Defect #01	Monitor	2	linear ft.

REPAIR: Monitor for possible future repair.

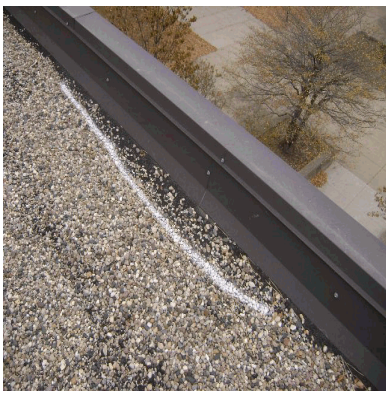
ID#: 1    OBSERVED: 10/10/12, 9/23/2015

Defect Type	Severity	Quantity	Unit
Defect #01	Monitor	50	sq. ft.

REPAIR: Monitor for repair need prior to reroofing

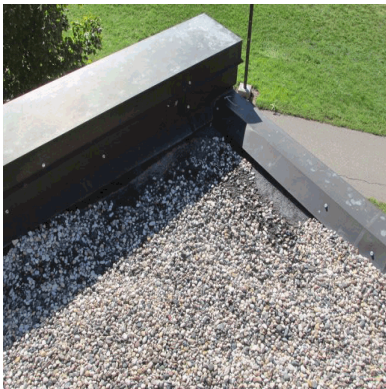
ID#: 2 OBSERVED: 10/09/13, 9/23/2015

Defect Type	Severity	Quantity	Unit
Defect #02	Monitor	6	sq. ft.

REPAIR: Monitor for repair need prior to reroofing

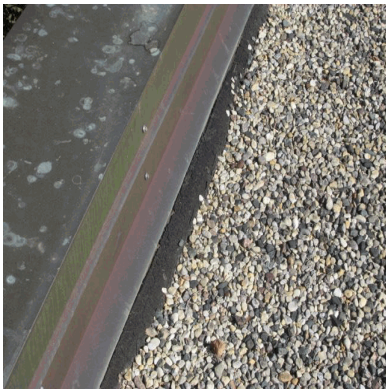
ID#: 2      OBSERVED: 10/09/13, 9/23/2015

Defect Type	Severity	Quantity	Unit
Defect #02	Monitor	5	sq. ft.

REPAIR: Monitor for repair need prior to reroofing

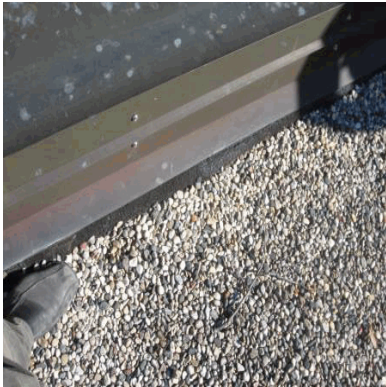
Defect Type	Severity	Quantity	Unit
Defect #01	Monitor	7	linear ft.

ID #1 OBSERVED: 9/23/2015

REPAIR: Monitor for possible future repair.

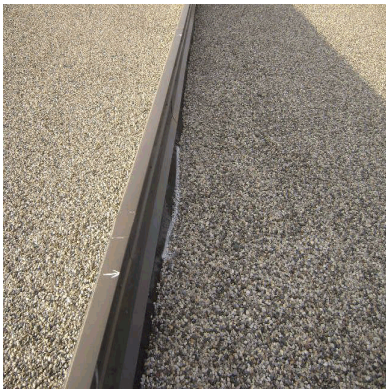
Defect Type	Severity	Quantity	Unit
Defect #01	Monitor	6	linear ft.

ID#: 1    OBSERVED: 10/10/12, 9/23/2015

REPAIR: Monitor for repair need prior to reroofing

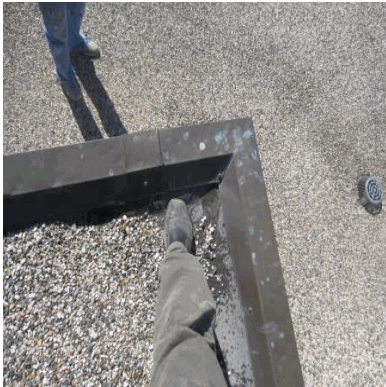
Defect Type	Severity	Quantity	Unit
Defect #01	Monitor	6	sq. ft.

ID #1 OBSERVED: 9/23/2015

REPAIR: Monitor for possible future repair.

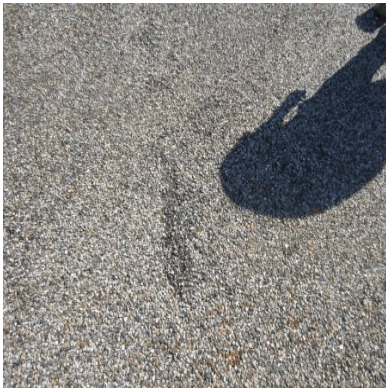
Defect Type	Severity	Quantity	Unit
Defect #02	Monitor	4	linear ft.

ID #2 OBSERVED: 9/23/2015

REPAIR: Monitor for possible future repair.

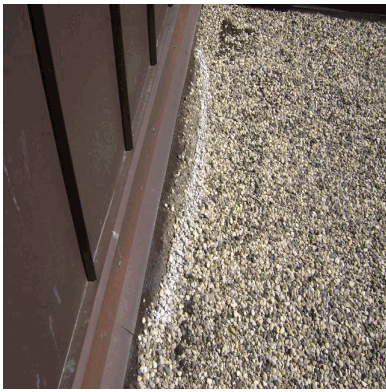
Defect Type	Severity	Quantity	Unit
Base Flashing	Monitor	6	Ea.

ID#: 1    OBSERVED: 10/10/12, 9/23/2015

REPAIR: Monitor for repair need prior to reroofing

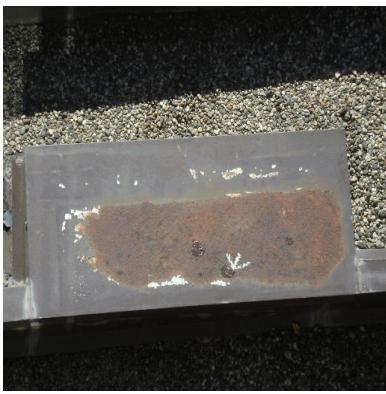
Defect Type	Severity	Quantity	Unit
Defect #01	Monitor	10	ft.

ID#: 1 OBSERVED: 10/10/12, 89/23/2015

Corroded/deteriorated/deformed/damaged metal

REPAIR: Monitor for repair need prior to reroofing

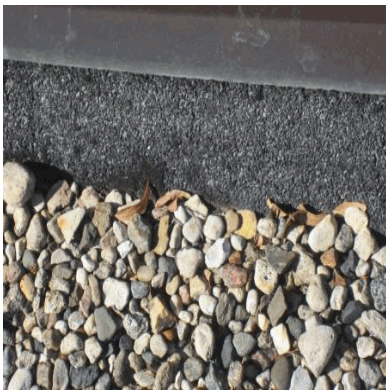
Defect Type	Severity	Quantity	Unit
Defect #02	Monitor	2	linear ft.

ID #2 OBSERVED: 9/23/2014

REPAIR: Monitor for possible future repair.

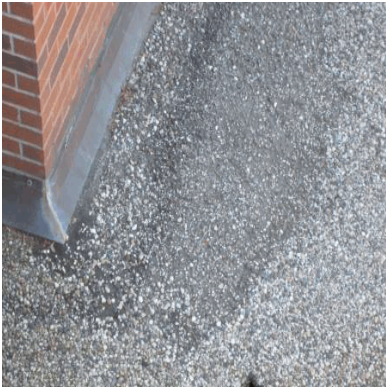
Defect Type	Severity	Quantity	Unit
Defect #03	Monitor	8	sq. ft.
ID #3    OBSERVED: 9/23/2015  Erosion of Aggregate Surfacing  REPAIR: Monitor for possible future repair.  COMMENTS:

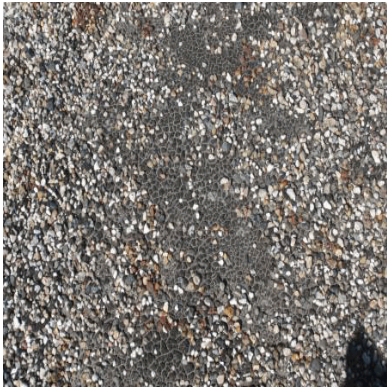
ID #2 OBSERVED: 9/23/2015

Defect Type	Severity	Quantity	Unit
Defect #01	Monitor	2	sq. ft.

REPAIR: Monitor for possible future repair.

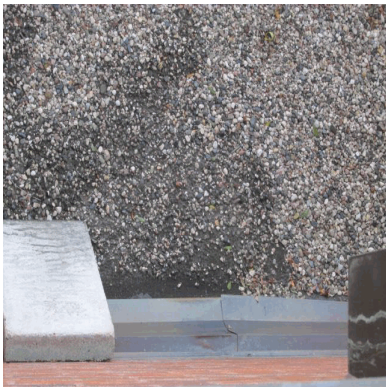
ID#: 2    OBSERVED: 10/09/13, 9/24/2015

Defect Type	Severity	Quantity	Unit
Defect #01	Monitor	20	sq. ft.

Surfacing loss with no membrane deterioration/damage

REPAIR: Monitor for repair need prior to reroofing

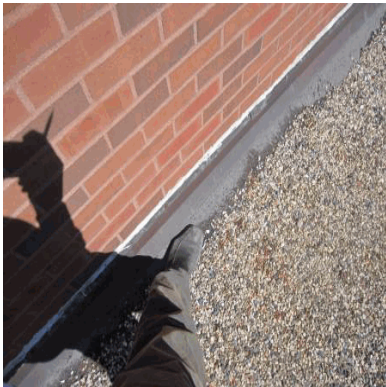
ID #2 OBSERVED: 9/24/2015

Defect Type	Severity	Quantity	Unit
Defect #02	Monitor	4	linear ft.

REPAIR: Monitor for possible future repair.

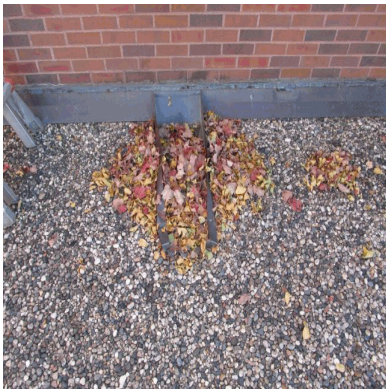
Defect Type	Severity	Quantity	Unit
No defects	Unknown	1	Ea.

Vegetation cleaned from roof and sealant applied to sheet metal insert at time of inspection.

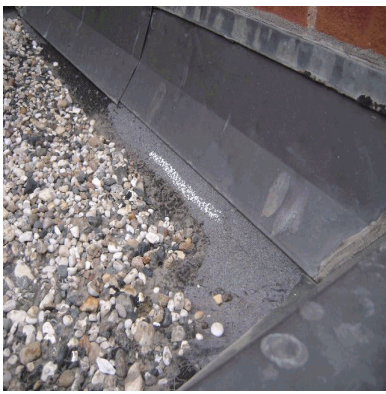
Defect Type	Severity	Quantity	Unit
Defect #01	Monitor	1	ft.

ID#: 1 OBSERVED: 10/10/12, 9/24/2015

REPAIR: Monitor for repair need prior to reroofing

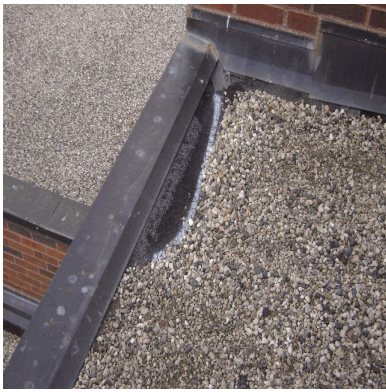
Defect Type	Severity	Quantity	Unit
Base Flashing	Monitor	2	Ea.

ID#: 1 OBSERVED: 10/10/12, 9/24/2015

REPAIR: Monitor for repair need prior to reroofing

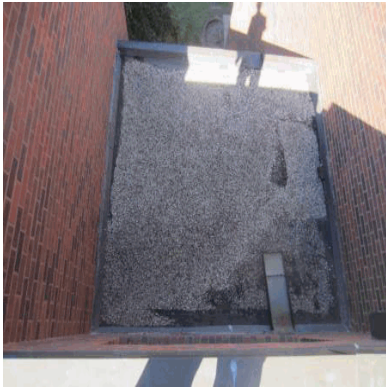
Defect Type	Severity	Quantity	Unit
Defect #01	Monitor	10	sq. ft.

ID #1 OBSERVED: 9/24/2015

REPAIR: Monitor for possible future repair.

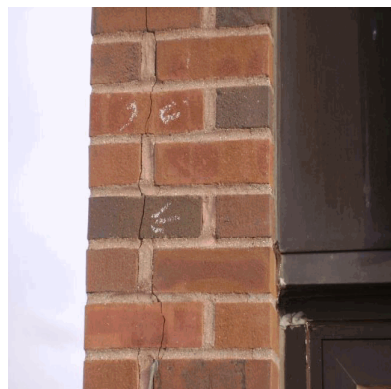
Defect Type	Severity	Quantity	Unit
Window/wall/waterproofing	Repair	1	Ea.

COMMENTS: Cracks in mortar joints and bricks at corner

REPAIR: Investigate and repair using appropriate procedures

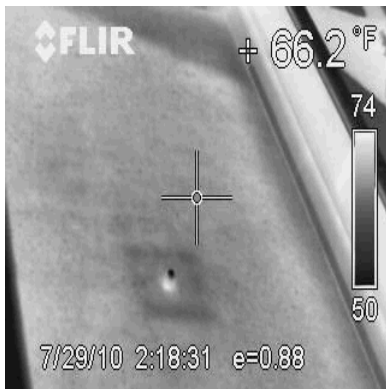
COMMENTS: Approx. 500 sq.ft.

REPAIR: Remove and replace all wet materials

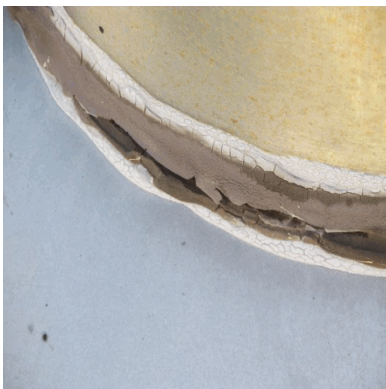
Defect Type	Severity	Quantity	Unit
Defect #03	Repair	3	linear ft.

ID#: 3 OBSERVED: 10/09/13, 9/23/2015

Top of sleeve or storm collar is open or missing

REPAIR: Reseal or replace as necessary

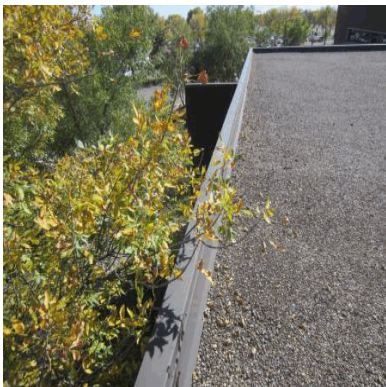
Defect Type	Severity	Quantity	Unit
Defect #04	Repair	2	Ea.

ID #4 OBSERVED: 9/23/2015

REPAIR: Remove vegetation and trim overhanging trees.

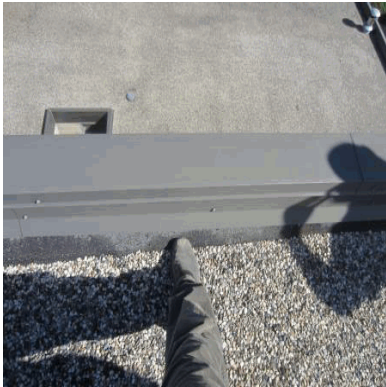
Defect Type	Severity	Quantity	Unit
Defect #01	Monitor	1	linear ft.

ID #1 OBSERVED: 9/23/2015

REPAIR: Monitor for possible future repair.

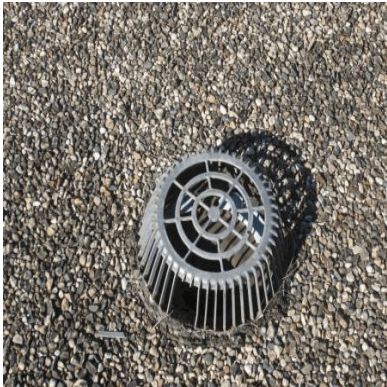
Defect Type	Severity	Quantity	Unit
Defect #01	Repair	1	Ea.
<p>ID #1    OBSERVED: 9/23/2015</p> <p>Broken Drain Screen</p> <p>REPAIR: Replace broken drain screen.</p> <p>COMMENTS:</p>

Budget Year	Activity Type	Quotation \$
2016	Repair	\$300
Replace damaged drain strainer.		
		<b>\$300</b>

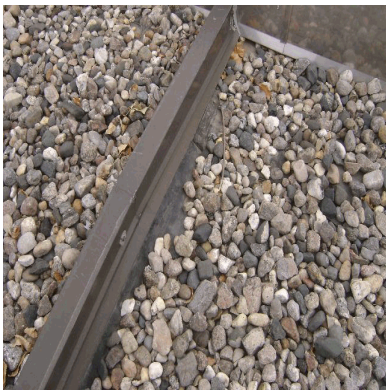
Defect Type	Severity	Quantity	Unit
Defect #01	Monitor	80	linear ft.

ID#: 1    OBSERVED: 10/10/12, 9/23/2015

COMMENTS: Appears to have increased in severity since previous inspection.

REPAIR: Monitor for repair need prior to reroofing

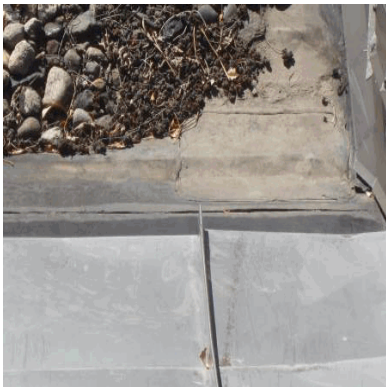
Defect Type	Severity	Quantity	Unit
Defect #02	Repair	4	linear ft.

ID #2    OBSERVED: 9/23/2015

REPAIR: Cover opening with new EPDM membrane.

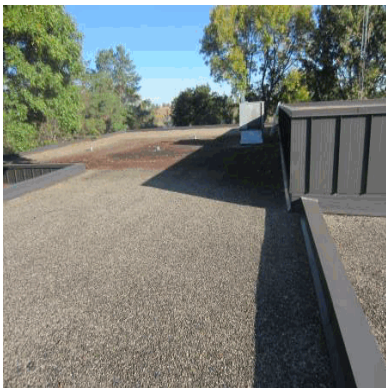
Defect Type	Severity	Quantity	Unit
Defect #04	Repair	1	Ea.

ID #4 OBSERVED: 9/23/2015

REPAIR: Trim overhanging tree and remove vegetation from the roof.

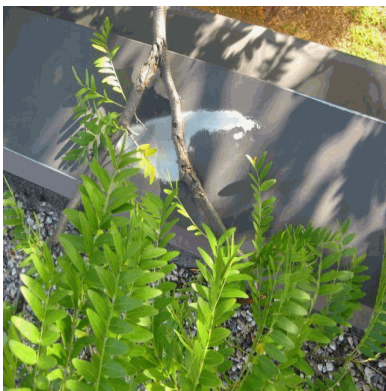
Defect Type	Severity	Quantity	Unit
Defect #02	Repair	1	sq. ft.

ID#:2 OBSERVED:10/9/2013, 9/24/2015

Tree branches overhanging roof

REPAIR: Trim tree branches away from roof. Paint damaged sheet metal

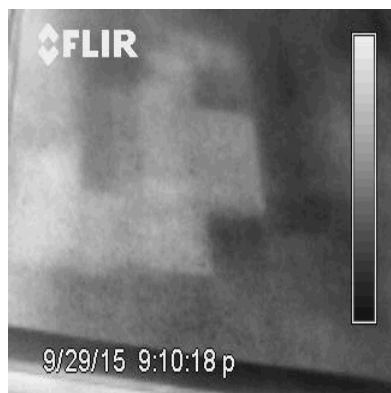
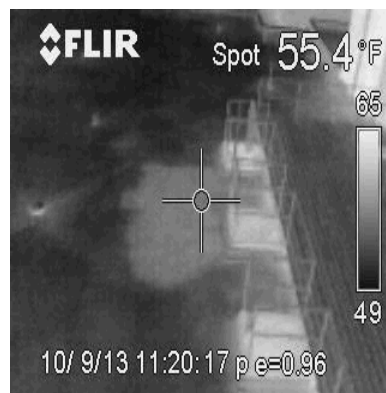
Defect Type	Severity	Quantity	Unit
Defect #03	Repair	500	sq. ft.

COMMENTS: A roofing contractor should provide, or should be present, when destructive testing to verify the presence of wet materials is conducted so that proper patching can be performed.

REPAIR: Remove and replace wet insulation

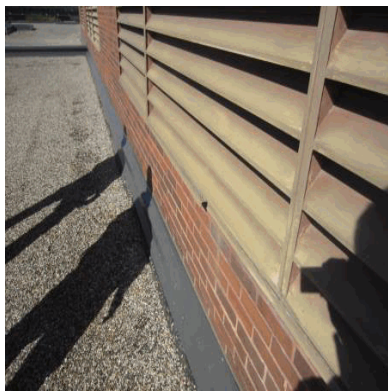
Defect Type	Severity	Quantity	Unit
Defect #04	Repair	1	Ea.

ID #4 OBSERVED: 9/24/2015

REPAIR: Resecure and seal metal flashing at louver.

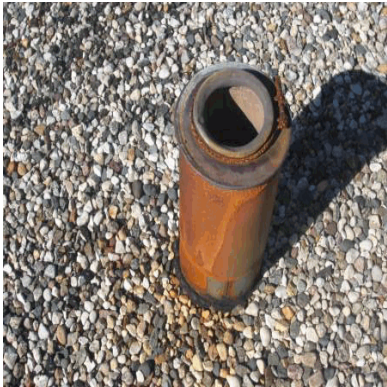
Defect Type	Severity	Quantity	Unit
Defect #05	Repair	1	Ea.
<p>ID #5    OBSERVED: 9/24/2015</p> <p>Corroded Metal Flashing</p> <p>REPAIR: Replace rusted soil stack flashing.</p> <p>COMMENTS:</p>

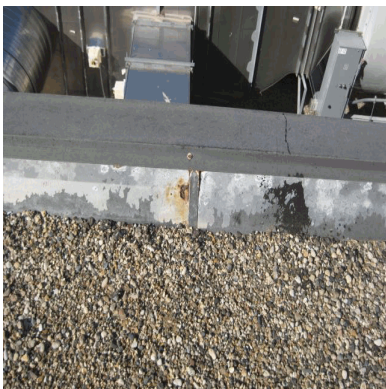
Defect Type	Severity	Quantity	Unit
Defect #05	Repair	25	linear ft.

ID#: 5 OBSERVED: 10/9/2013, 9/24/2015

Corroded/deteriorated/deformed/damaged metal

REPAIR: Replace

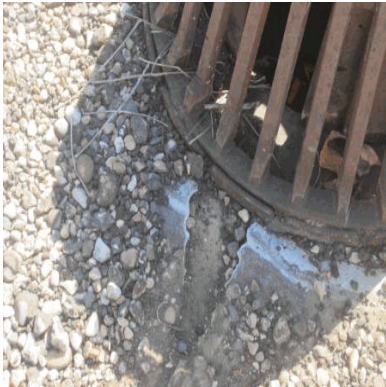
Defect Type	Severity	Quantity	Unit
Defect #07	Repair	1	Ea.

ID #7 OBSERVED: 9/24/2015

REPAIR: Replace existing drain lead.

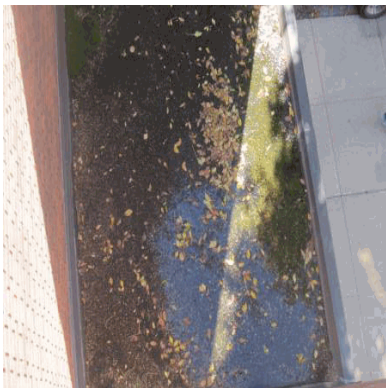
Defect Type	Severity	Quantity	Unit
Defect #08	Repair	1	Ea.

ID #8 OBSERVED: 9/24/2015

COMMENTS: Obstructed drainage is causing the roof to pond water.

REPAIR: Clean debris from roof and clear scupper

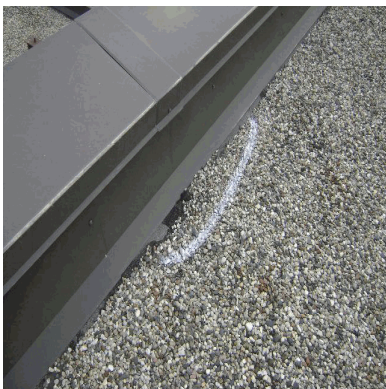
Defect Type	Severity	Quantity	Unit
Defect #01	Monitor	4	ft.

ID#: 1 OBSERVED: 10/10/12, 9/24/2015

REPAIR: Monitor for repair need prior to reroofing

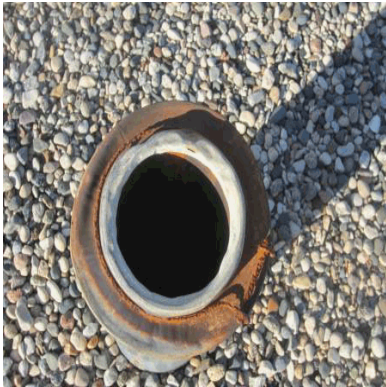
Defect Type	Severity	Quantity	Unit
Defect #01	Repair	1	Ea.

ID #1 OBSERVED: 9/24/2015

Corroded Metal Flashing

REPAIR: Replace rusted stack flashing.

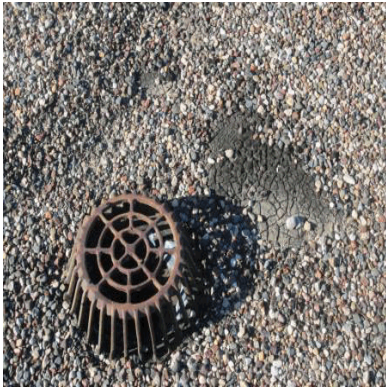
Defect Type	Severity	Quantity	Unit
Defect #01	Monitor	4	sq. ft.

ID #1 OBSERVED: 9/24/2015

REPAIR: Monitor for possible future repair.

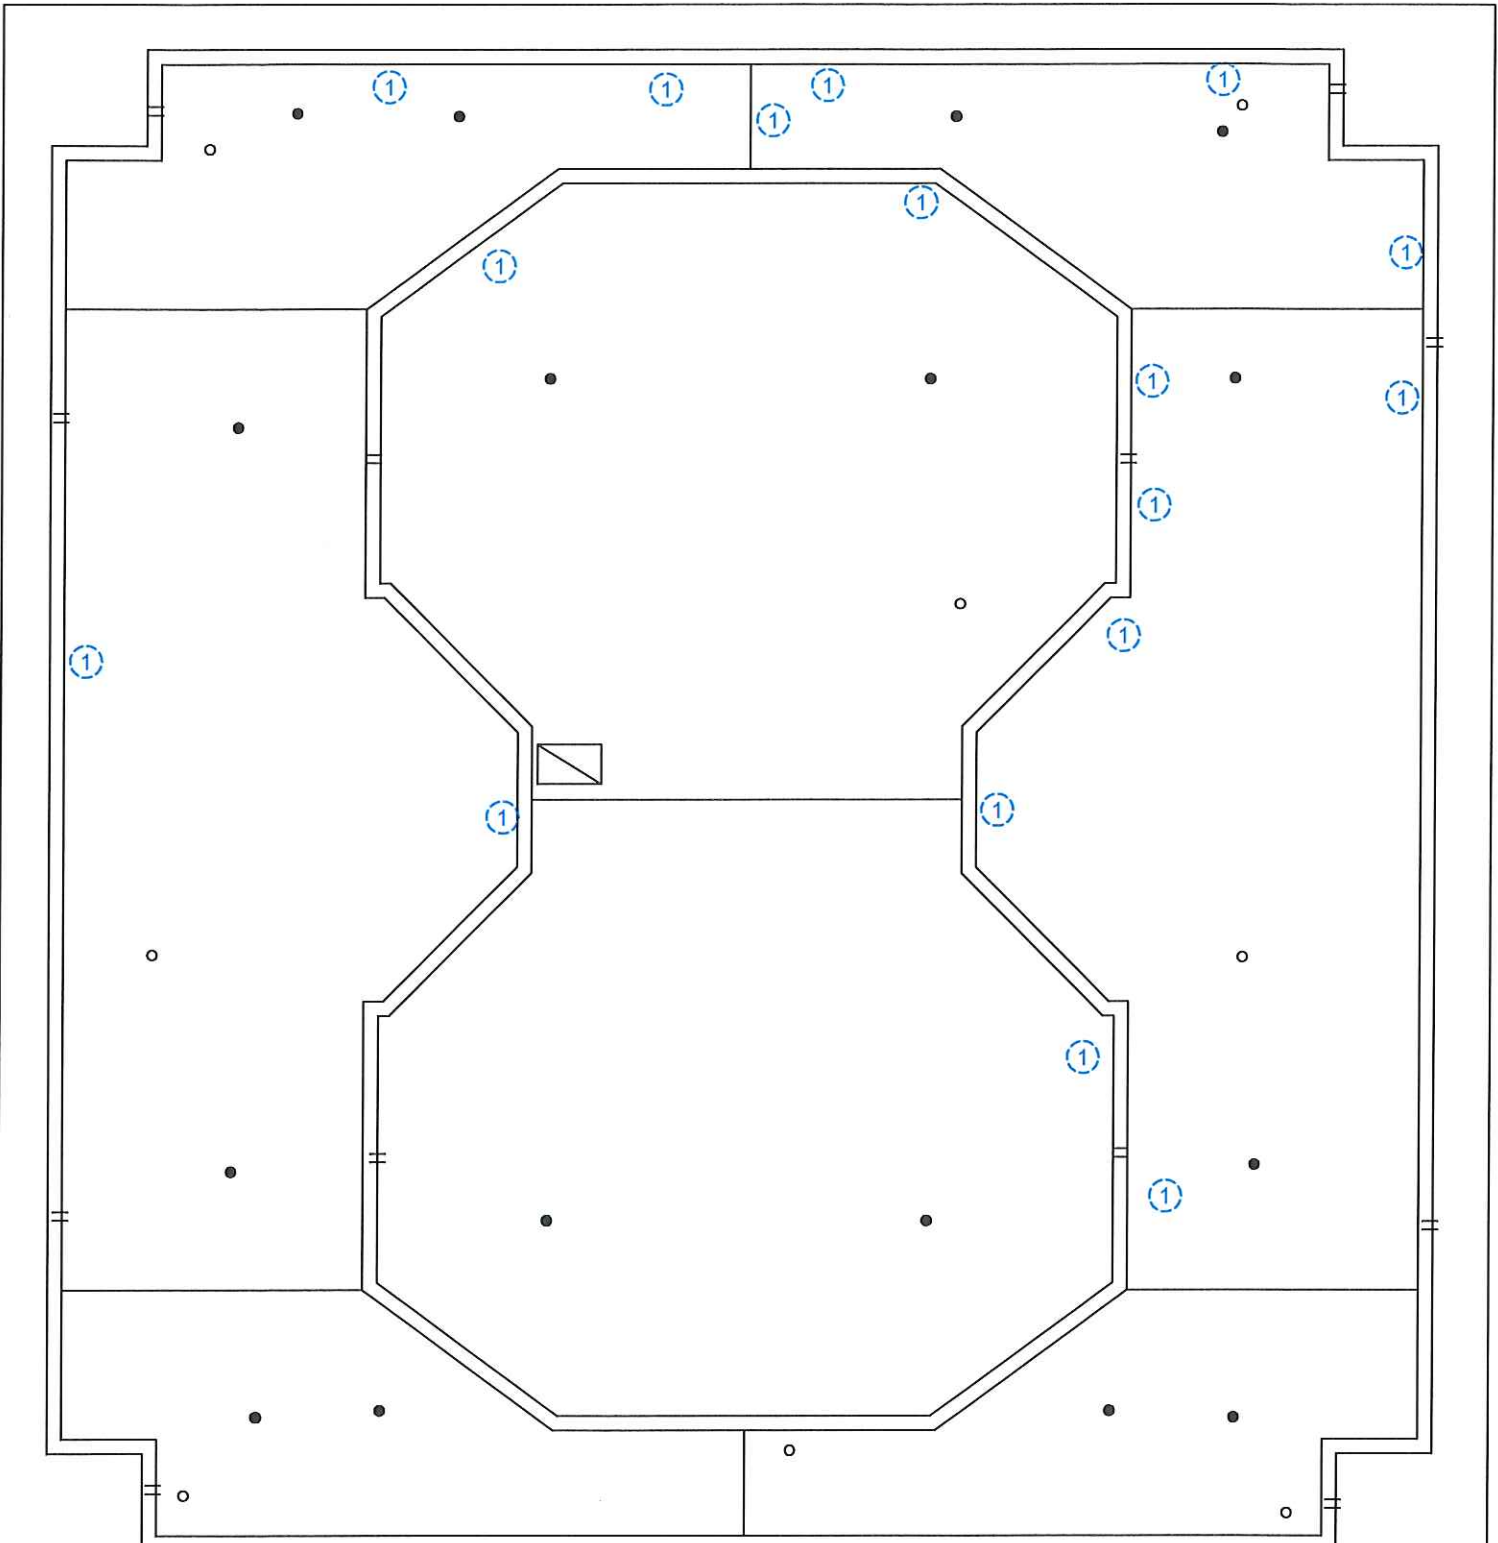
- DEFECT KEY**
- ① MEMBRANE BLISTER

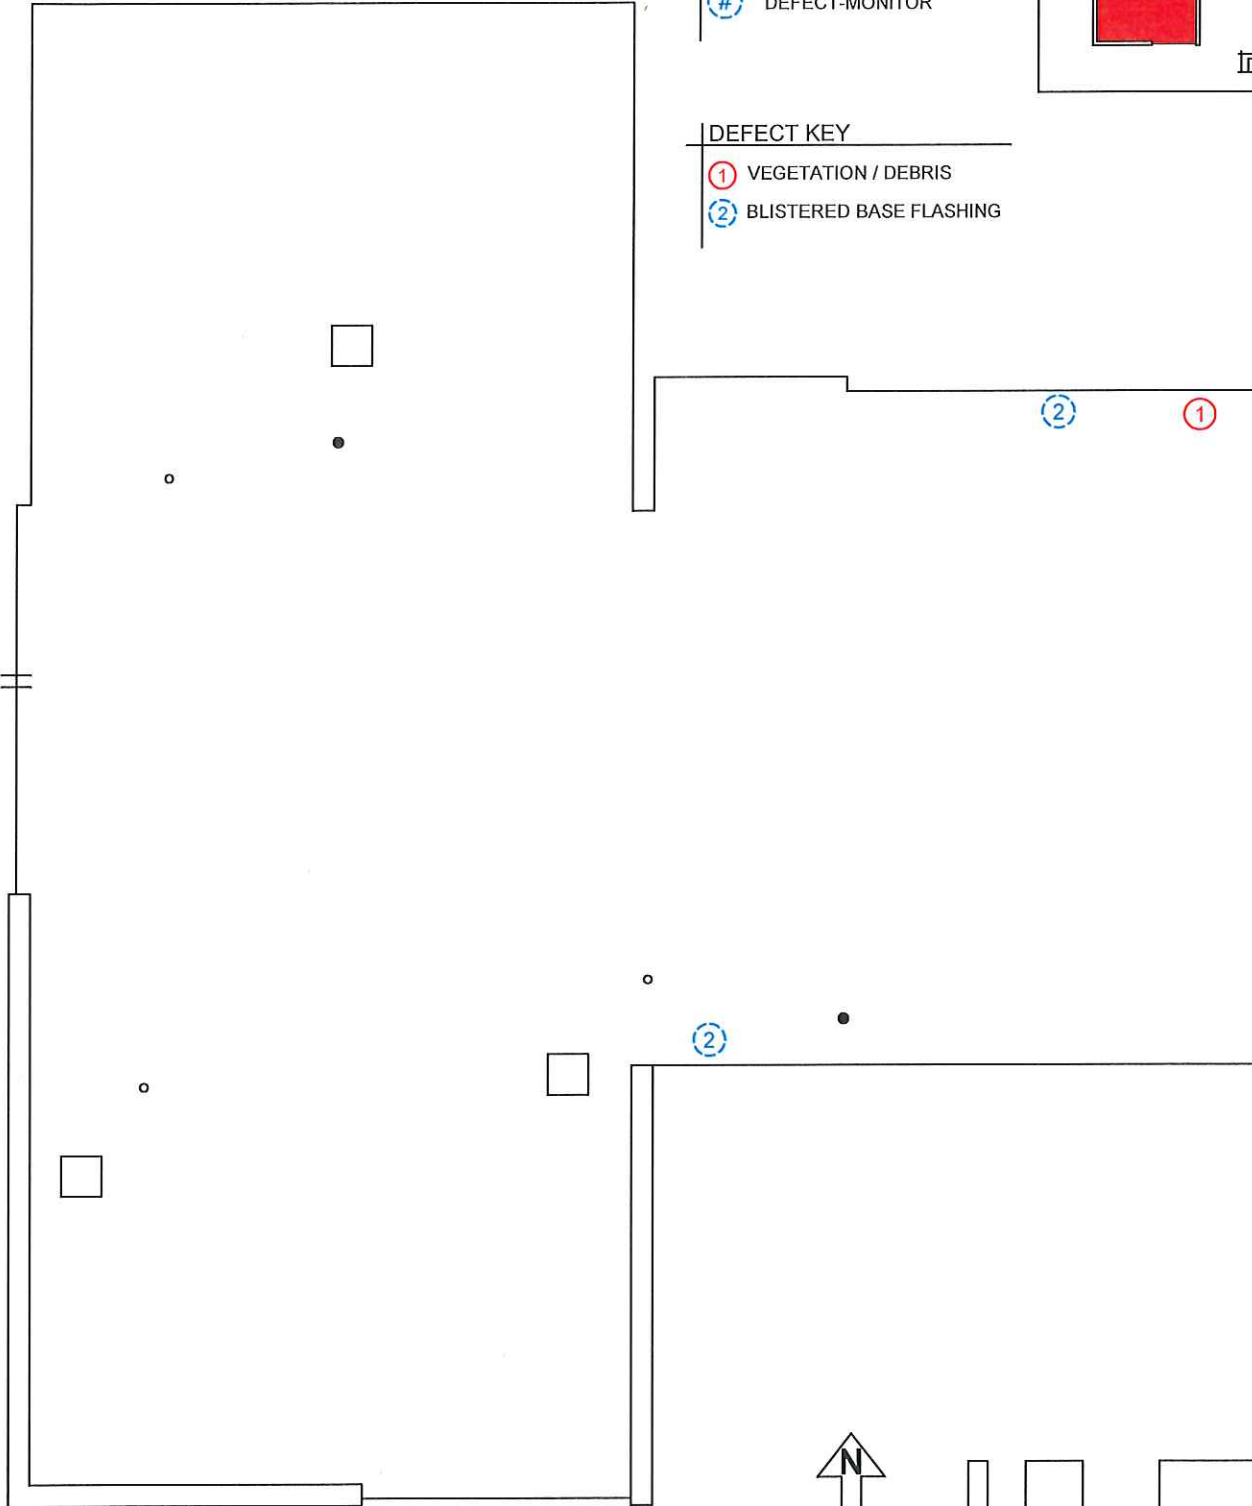
- ① VEGETATION / DEBRIS
- ② BLISTERED BASE FLASHING

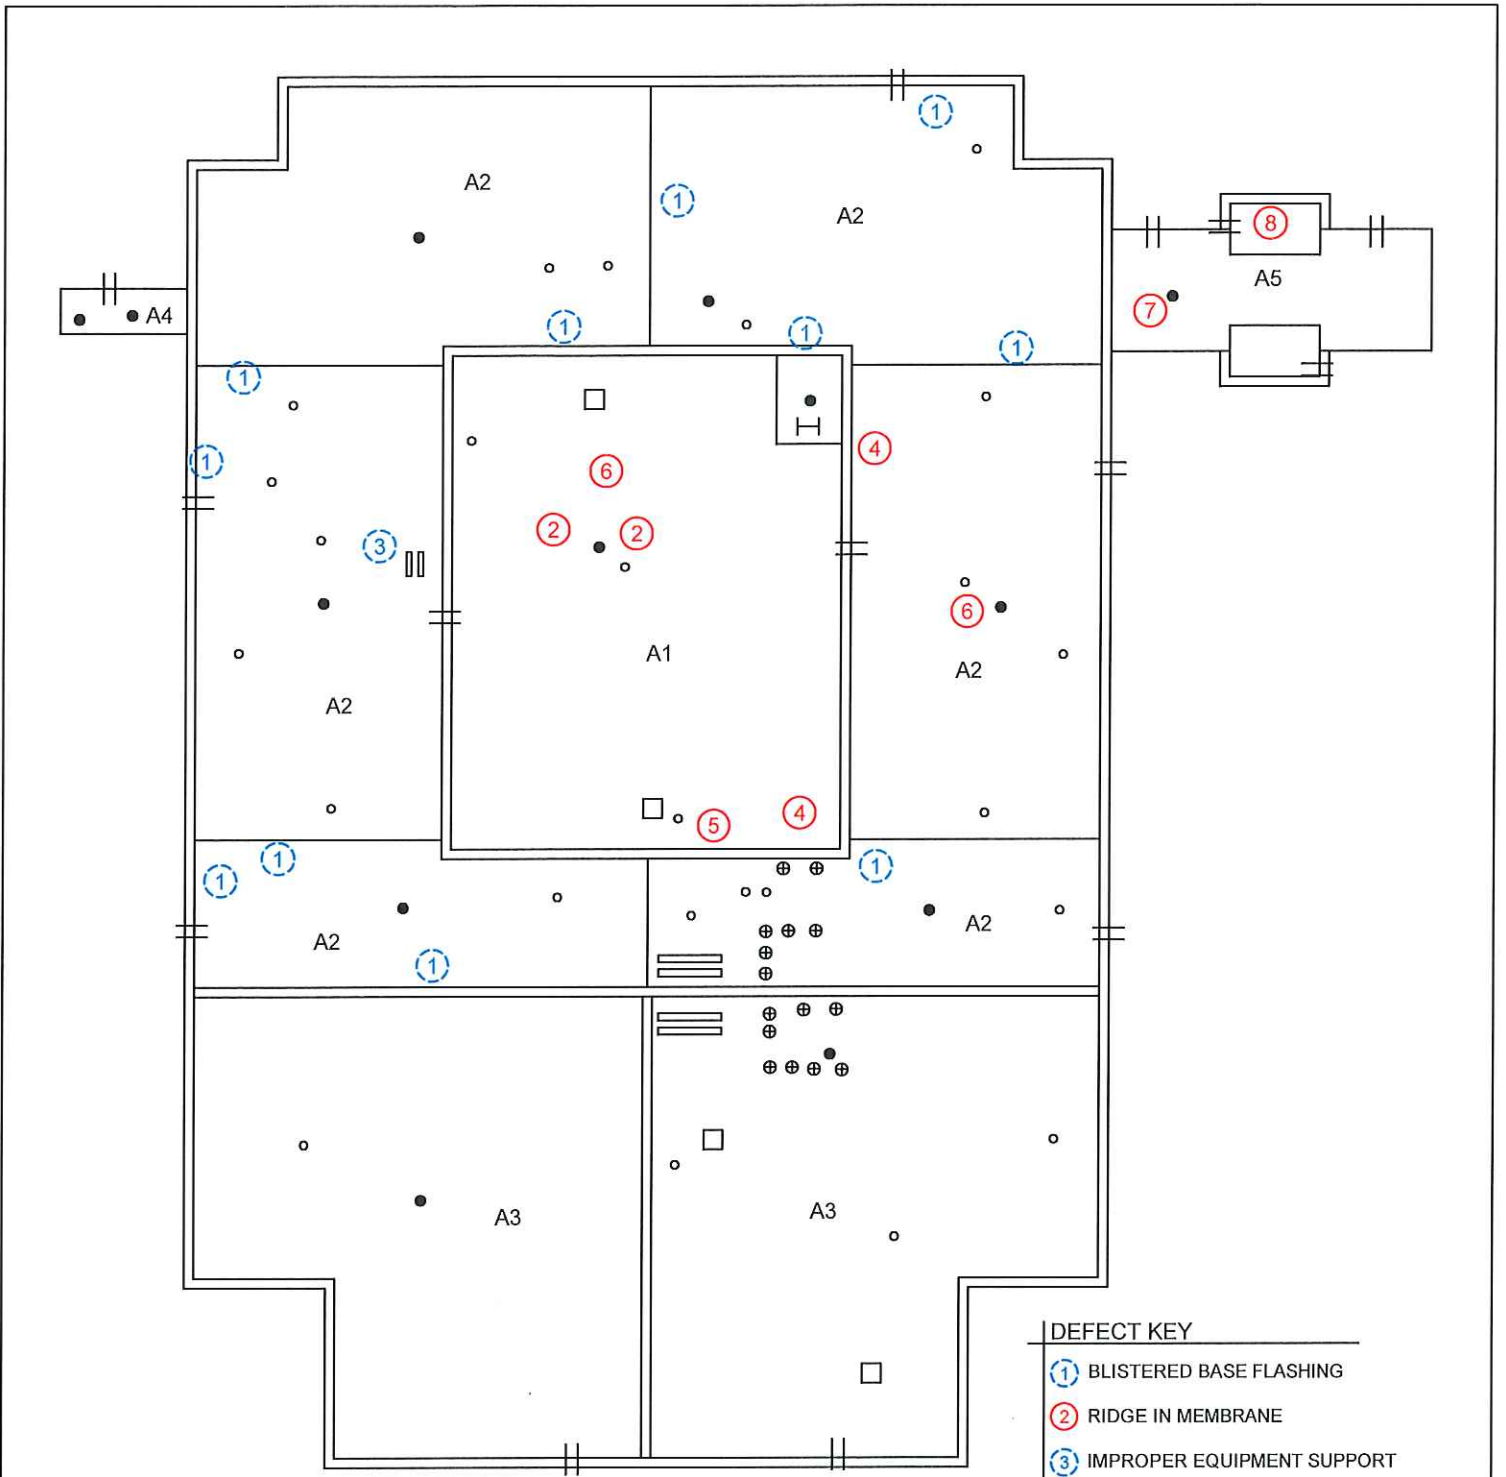
DEFECT KEY	
①	BLISTERED BASE FLASHING
②	RIDGE IN MEMBRANE
③	IMPROPER EQUIPMENT SUPPORT
④	DETERIORATED BASE FLASHING
⑤	CORRODED SHEET METAL
⑥	SUSPECTED WET INSULATION
⑦	SPLIT DRAIN LEAD
⑧	PLUGGED SCUPPER

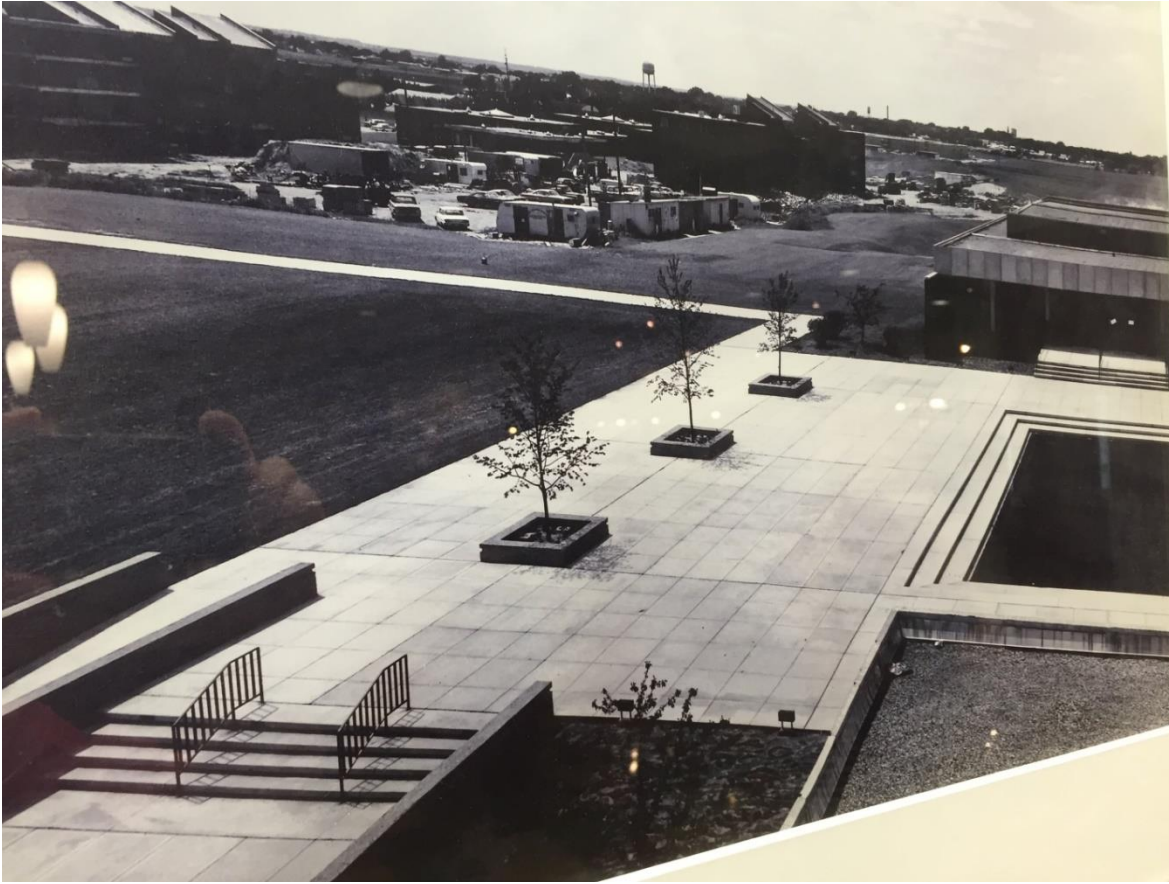
1969 Central Quad shows conditions open to the south with construction staging under way for student housing to extend west. Photo of original photo by Henry Kyllingstad (©SMSU Archival Records) taken by the author 5/28/2015.

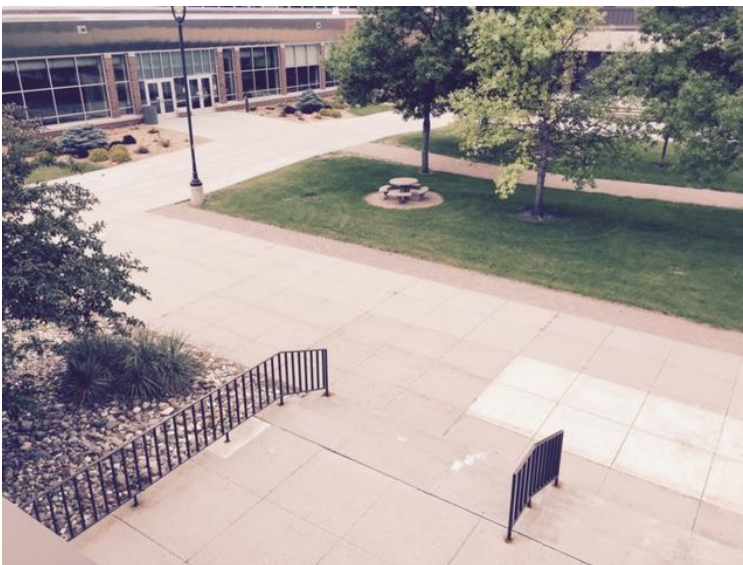
Central Quad, south end of the flush-condition central green. Photo by the author 5/28/2015.

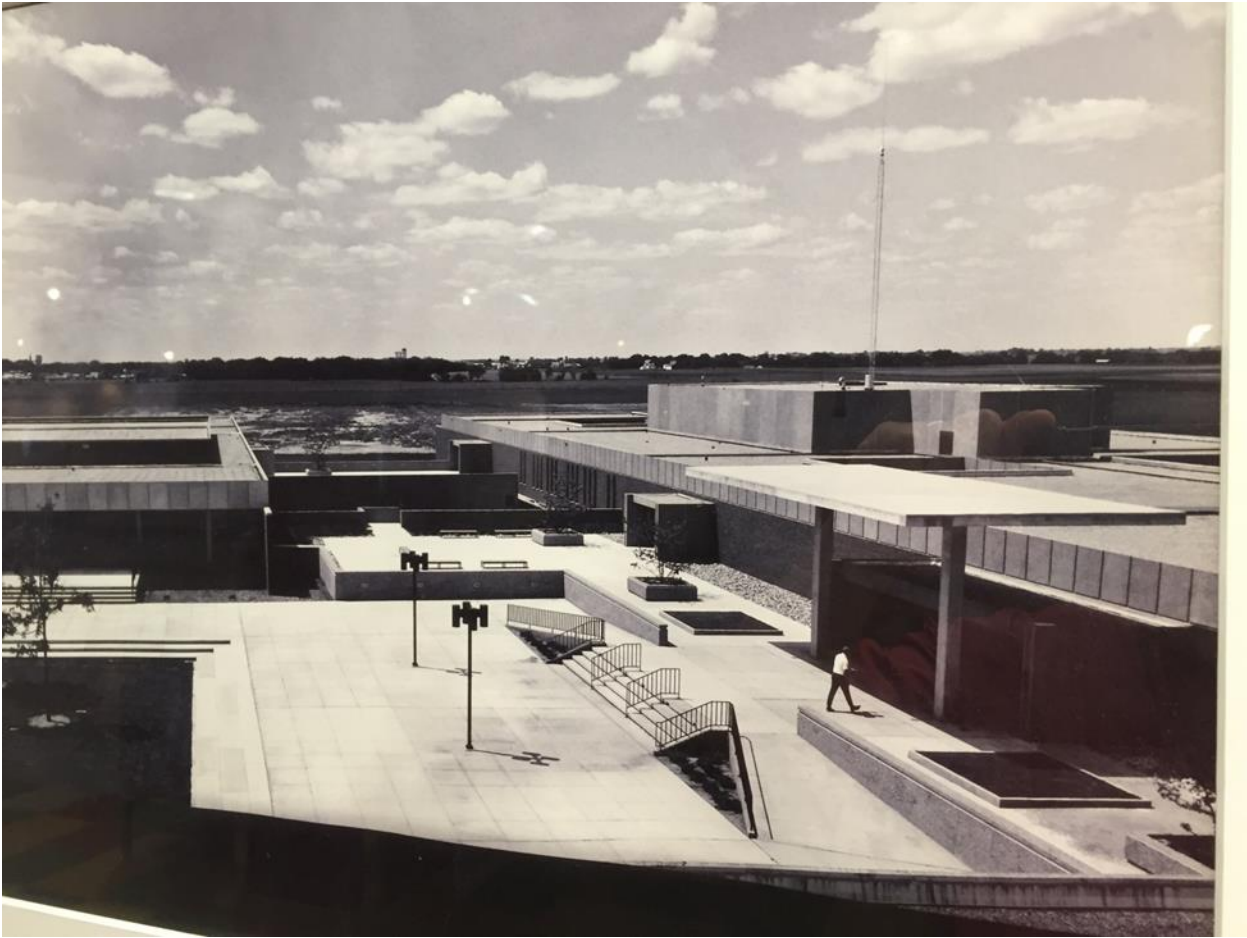
1969 Central Quad, north end and Bellows Academic Center entrance terrace. Photo of original photo by Henry Kyllingstad (©SMSU Archival Records) taken by the author 5/28/2015.
