Southwest Minnesota State University

MASTER FACILITY PLAN 2017

100% | 2.13.2018

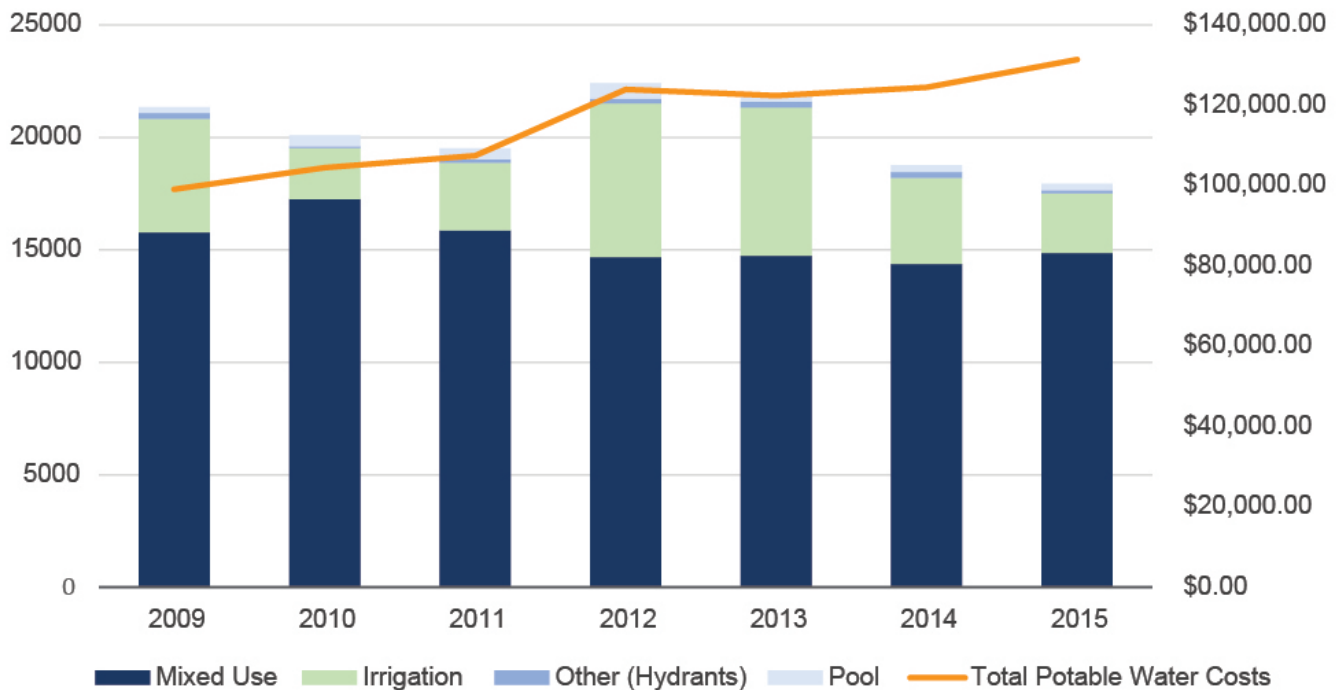
Total Annual Potable Water Use & Costs (2009 - 2015)

Water use has remained approximately the same each year since 2009. Indoor water use has decreased slightly each year since 2009 while summer outdoor has generally increased. Water use was high in 2009, then again in 2012 & 2013. 2014 summer water use dropped slightly so that the total annual use dropped to 12.05% below the 2009 baseline for the first time since 2011. Due to the high level of variability of use during summer months, it is difficult to determine if there is an overall improvement in water use on campus. SMSU has a relatively well documented set of water meters, providing an opportunity for the campus to more effectively target areas for water use reduction that will result in water savings. While use has stayed generally the same, water costs have almost doubled from 2009 to 2015.
